DETERMINATION OF STRESSES ON LAMINATED AIRCRAFT  
TRANSPARENCIES BY THE STRAIN GAGE-HOLE DRILLING  
AND SECTIONING METHOD

Thomas J. Whitney  
Gregory J. Stenger  
University of Dayton Research Institute  
300 College Park  
Dayton, Ohio 45469-0110

Final Report for Period January 1989 - September 1990

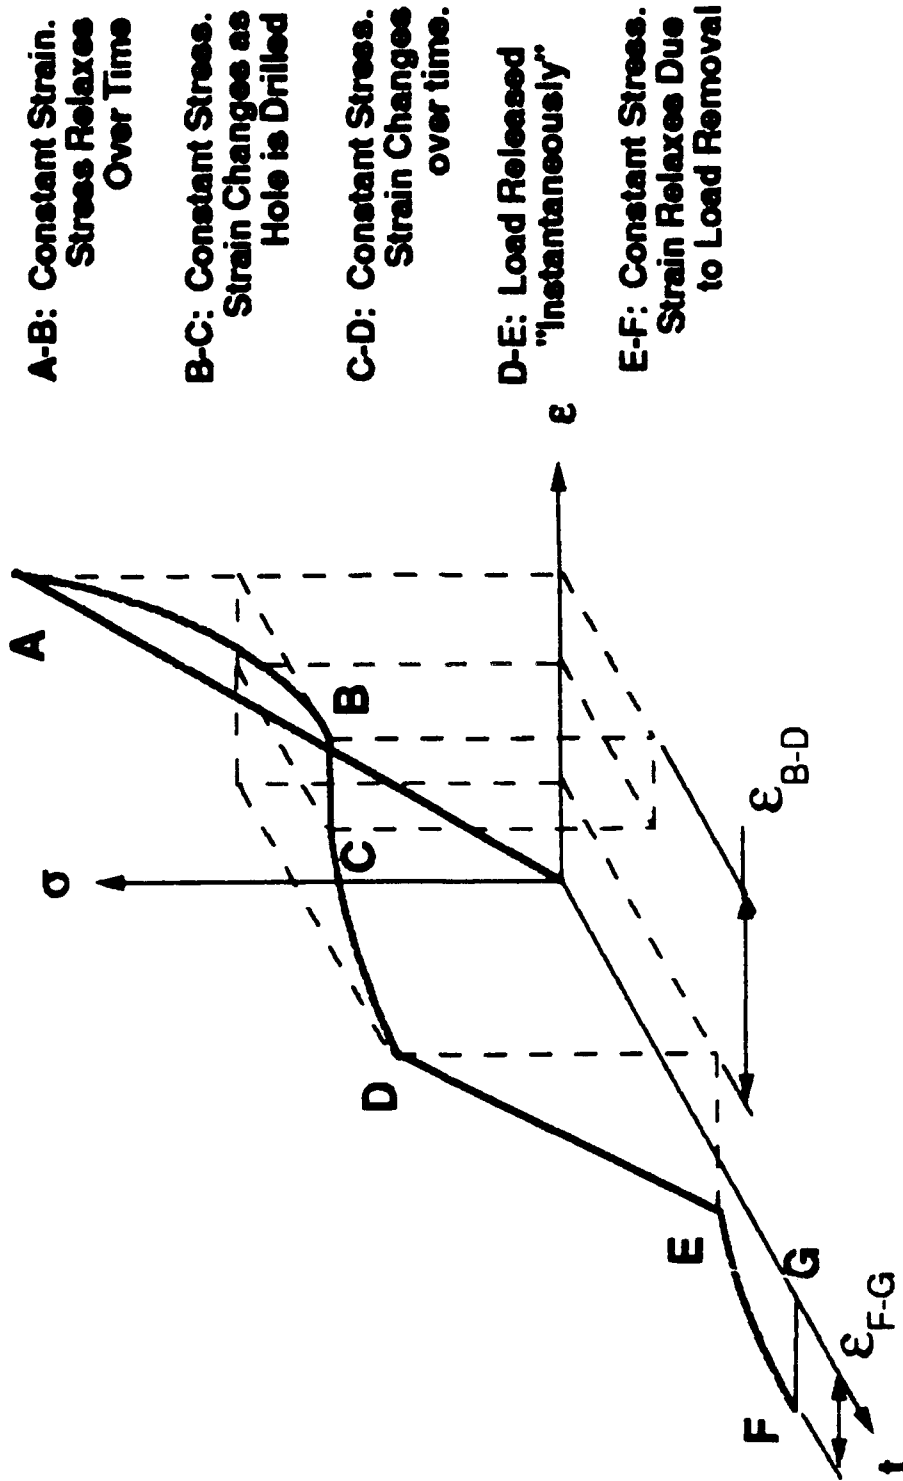
Figure 2.7. Calibration Loading Path for Viscoelastic Materials.

Since the fixture prescribes a constant fixed displacement on the specimen, the stress in the sample relaxes. This relaxation occurred over an 8-minute period, during which the drill was centered. Allowing the specimens to relax for 8 minutes permitted the existence of a nearly "constant" stress state for drilling, as would exist in a canopy outer layer (by assumption, the installation of a canopy is a fixed displacement condition, which results in stress relaxation of initial installation stresses to a constant level over time). The stress in the specimen is "constant" in the sense that the stress does not change significantly in the time it takes to drill the hole. Drilling relieves strain from point B to C. However, as the new stress state is constant, the strain continues to change over time (creep) from C to D. After an 8-minute period, release of the load (point E) as in the elastic case, indicates drilling induced stresses (other stresses) not associated with the mechanical loading. As this is a fixed change in load (load at drill to zero load), creep again occurs (E to F). After an 8-10 minute period, during which the strain approaches a "constant" value, the strain at F is taken as the nonmechanical strain. Subtraction of the strain at F from the strain difference (D-B) is taken as the strain relieved due to a constant stress at B. Using this calibration technique allows the hole drilling method to be calibrated to the relaxed strain state (strain after creep) achieved by drilling the hole. The advantage is that the relaxed strain state is much easier to identify than any other transient strain state.

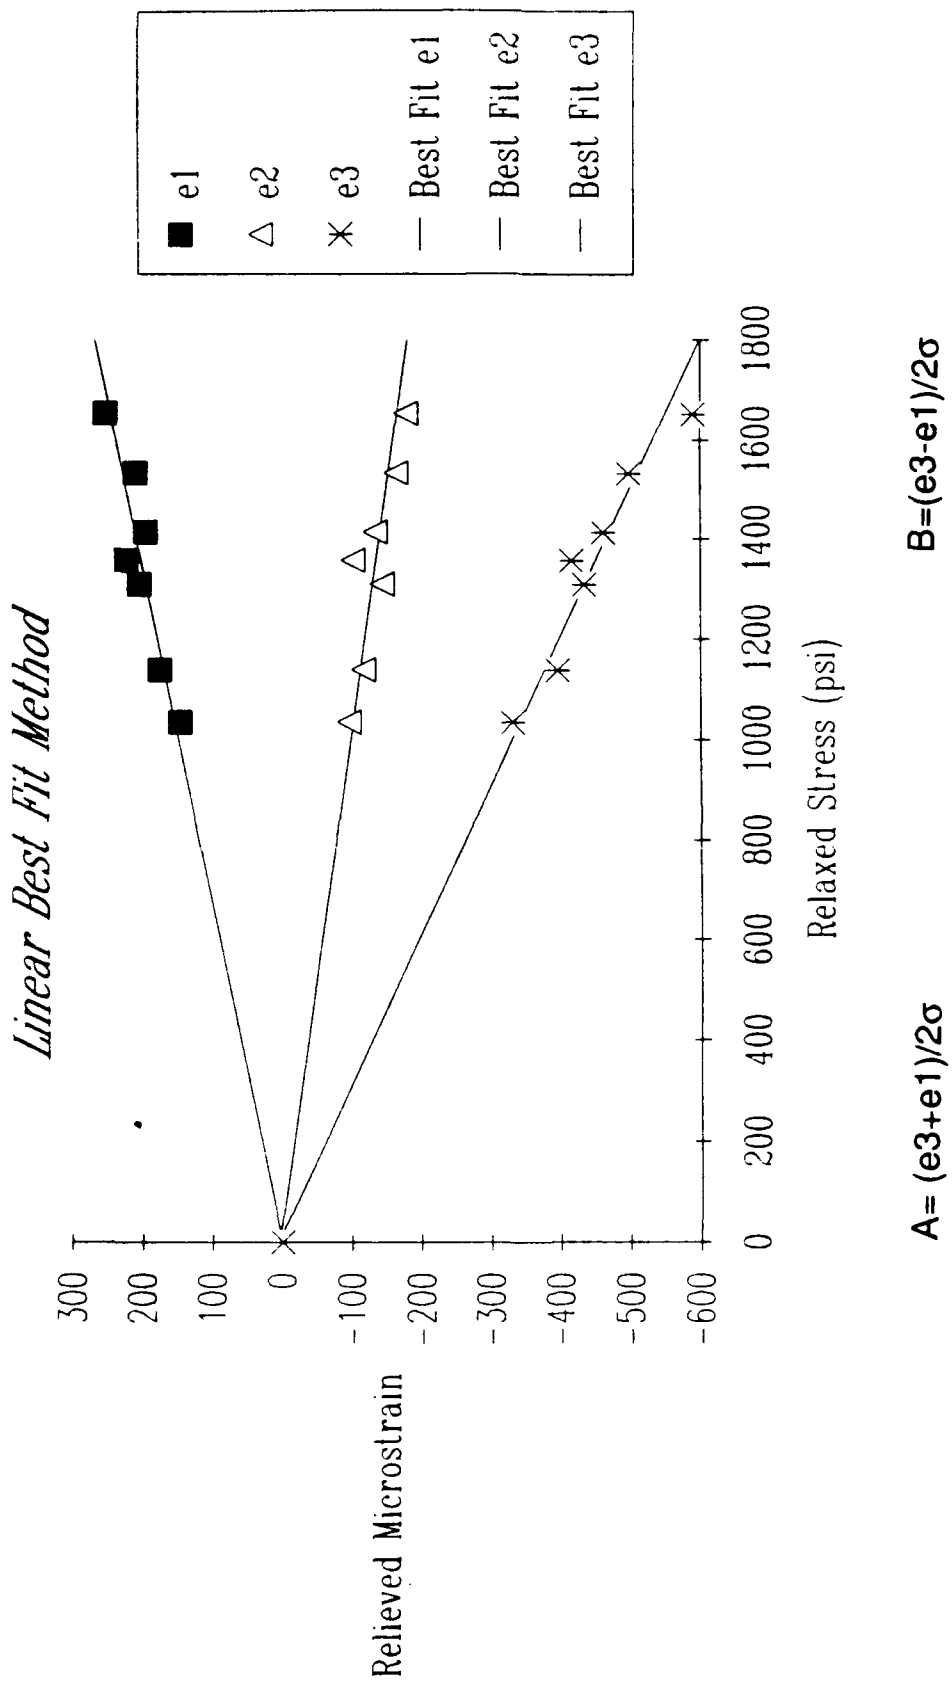
Figure 2.8. Strain Data from Acrylic Calibration.

yield the required calibration coefficients. For acrylic, equations (6) and (7) give the values

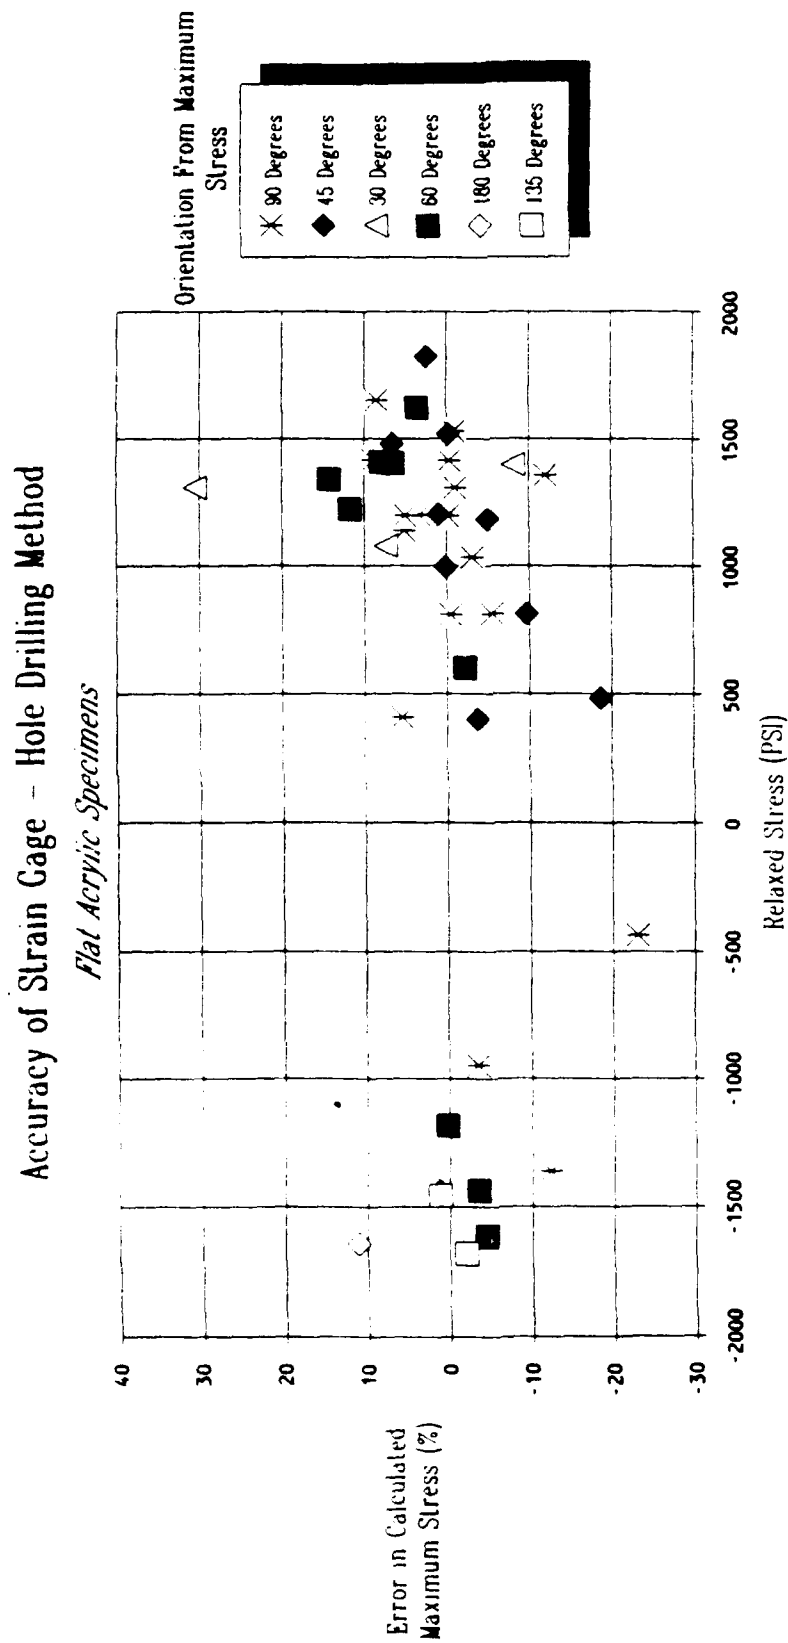
Figure 2.9. Uniaxial Verification Results.

ROSETTE	STRESS (psi)			MAXIMUM PRINCIPAL STRESS ANGLE (degrees)	
	$\sigma_{\text{actual}}$	$\sigma_{\text{measured}}$	$\Delta\%$	$\beta_{\text{actual}}$	$\beta_{\text{measured}}$
A	1647	1694	2.85	90	89.8
B	1392	1375	-1.22	90	90.7
C	1627	1667	2.46	60	59.2
D	1389	1342	-3.38	45	45.2
E	1652	1602	-3.03	45	43.8

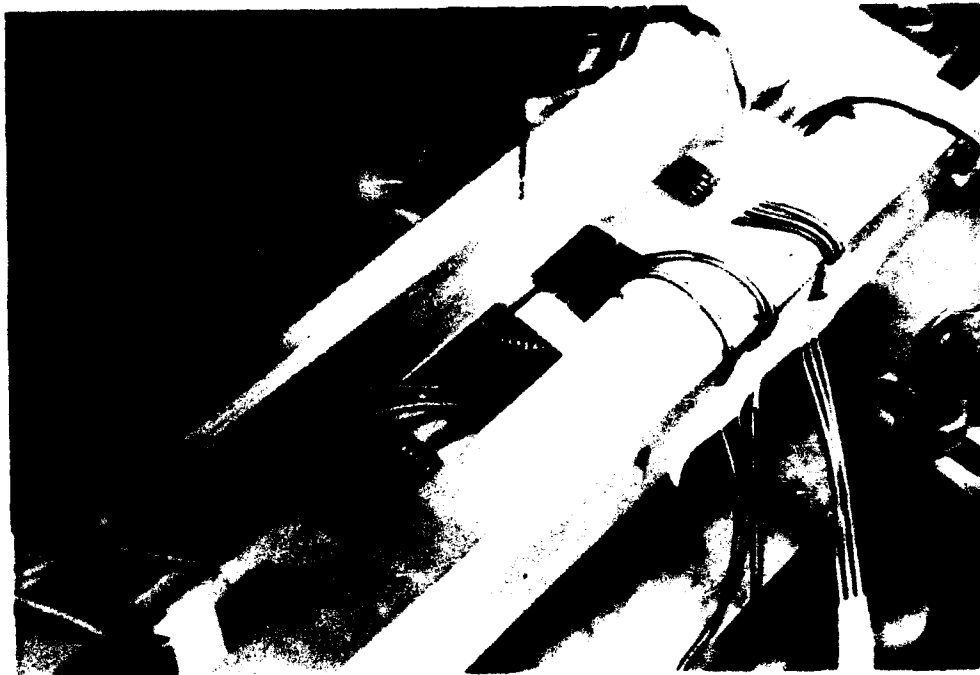
Figure 2.10. Compression Verification Tests.

Figure 2.9 displays accuracy results for verification tests run in uniaxial tension and compression. Test samples retained the exact configuration as the calibration specimens. Antibuckling rails prevented buckling of the compression samples as seen on Figure 2.10. Previous work [12] indicated residual stresses in the range 300-2000 psi may exist in the acrylic layer. This work dictated the range of uniaxial verification loads used in this study.

For 92% of the holes drilled, the error remained within  $\pm 12\%$ . The scatter shows no preferential toward positive or negative error, nor any increase in error with a particular rosette orientation. The inability of the material to relax in compression tests, due to friction from the antibuckling fixture, most likely accounts for the high error at -460 psi. Inaccurate centering of the drill accounted for the 30% error in the 30° rosette at 1300 psi. In addition, error below 500 psi appears no greater than error at high stress levels.

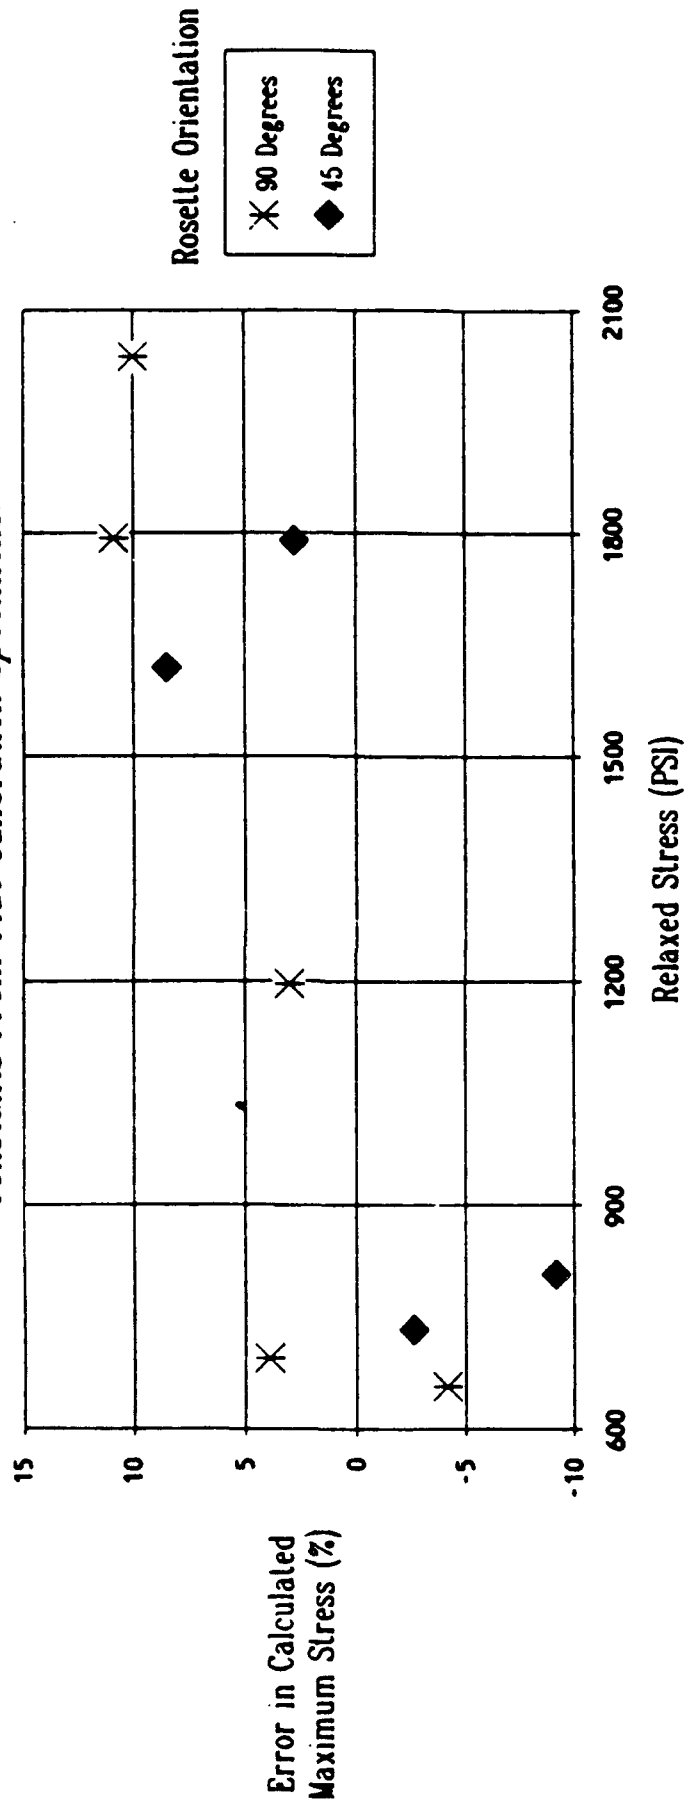
Figure 2.11. Curved Surface Uniaxial Verification Results.

# Accuracy of Residual Stress Determination on Transversely Curved ( $k=0.2$ ) Surfaces

*Constants From Flat Calibration Specimens.*

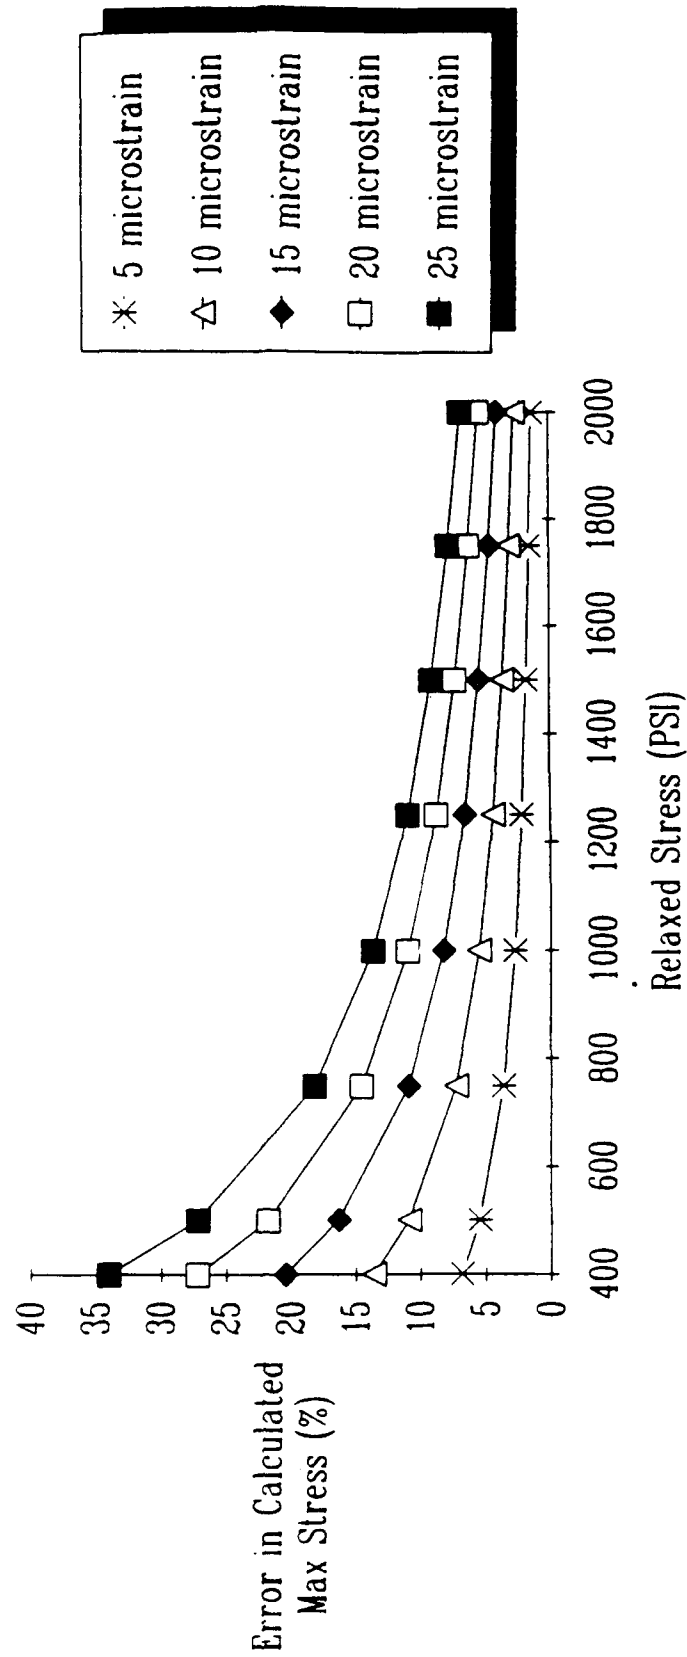
Figure 3.1. Theoretical Residual Stress Error.

# Effect of Error in Measured Strain on Residual Stress Measurement

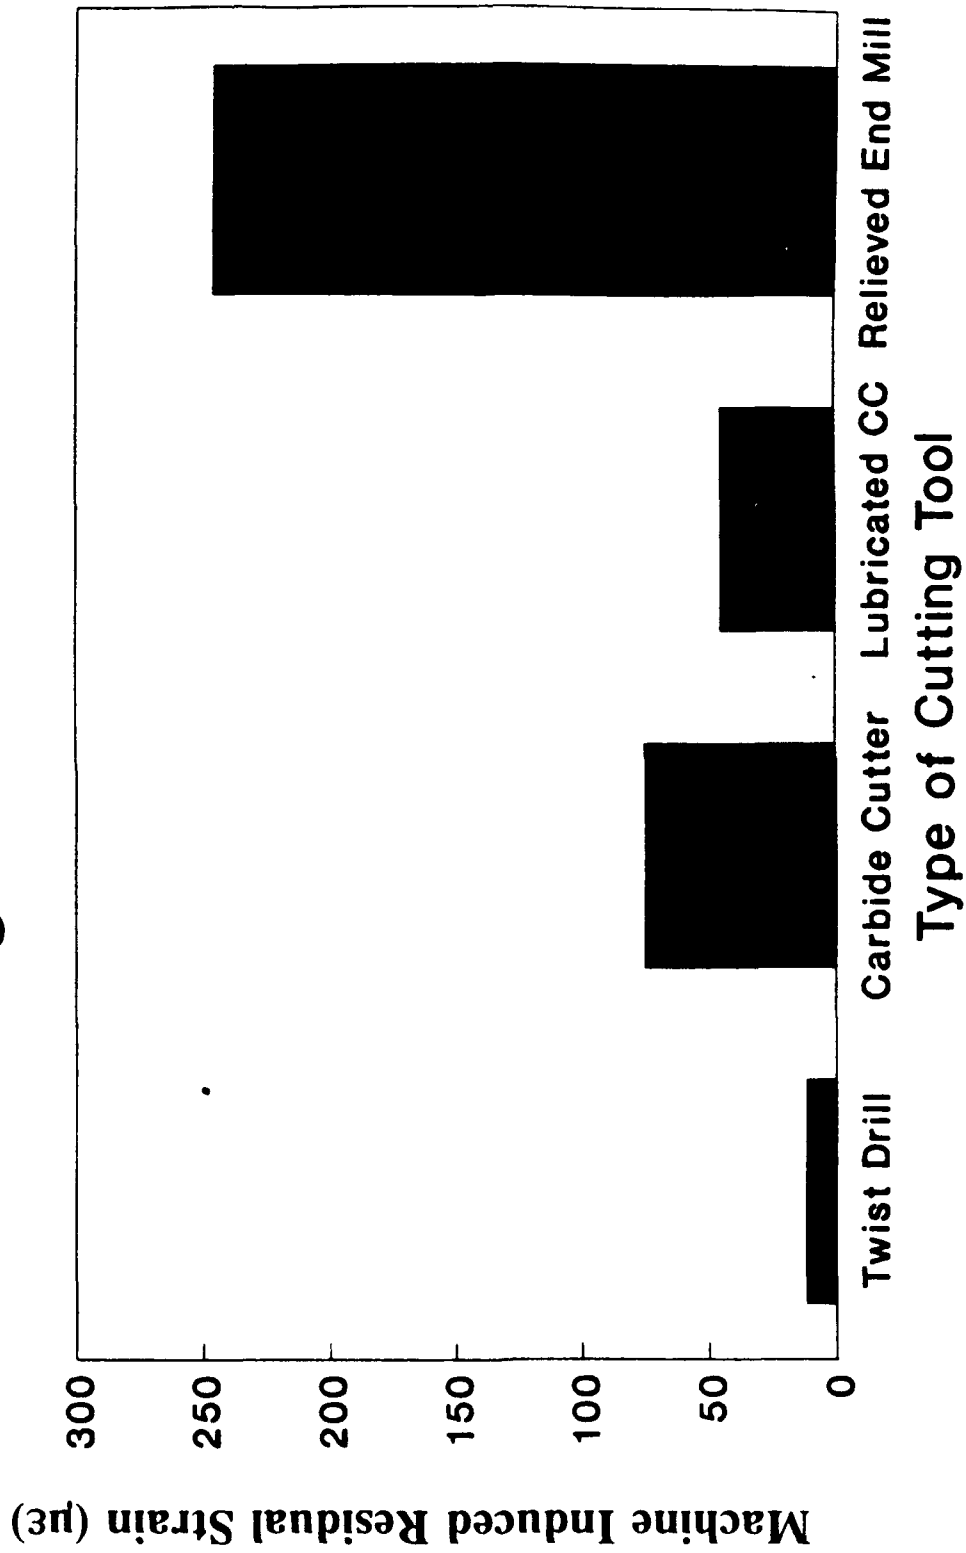
Figure 3.2. Optimal Machining Methods for Acrylic.

Reverse cone carbide cutters and end mills are frequently used in hole drilling metals. They proved ineffective in the acrylic. The use of lubricants with the carbide cutter resulted in a decrease in residual strain, but not to a sufficient degree to warrant its use. High speed (100,000 rpm) drilling using the carbide cutter (another method widely employed in metals), conducted in unloaded preshrunk acrylic, resulted in enormous residual strains (Figure 3.3). This likely generated enough friction heat to degrade the polymer, resulting in high drill-induced stress. As the figure demonstrates, ordinary high speed steel twist drills produced the lowest "machining induced" strains.

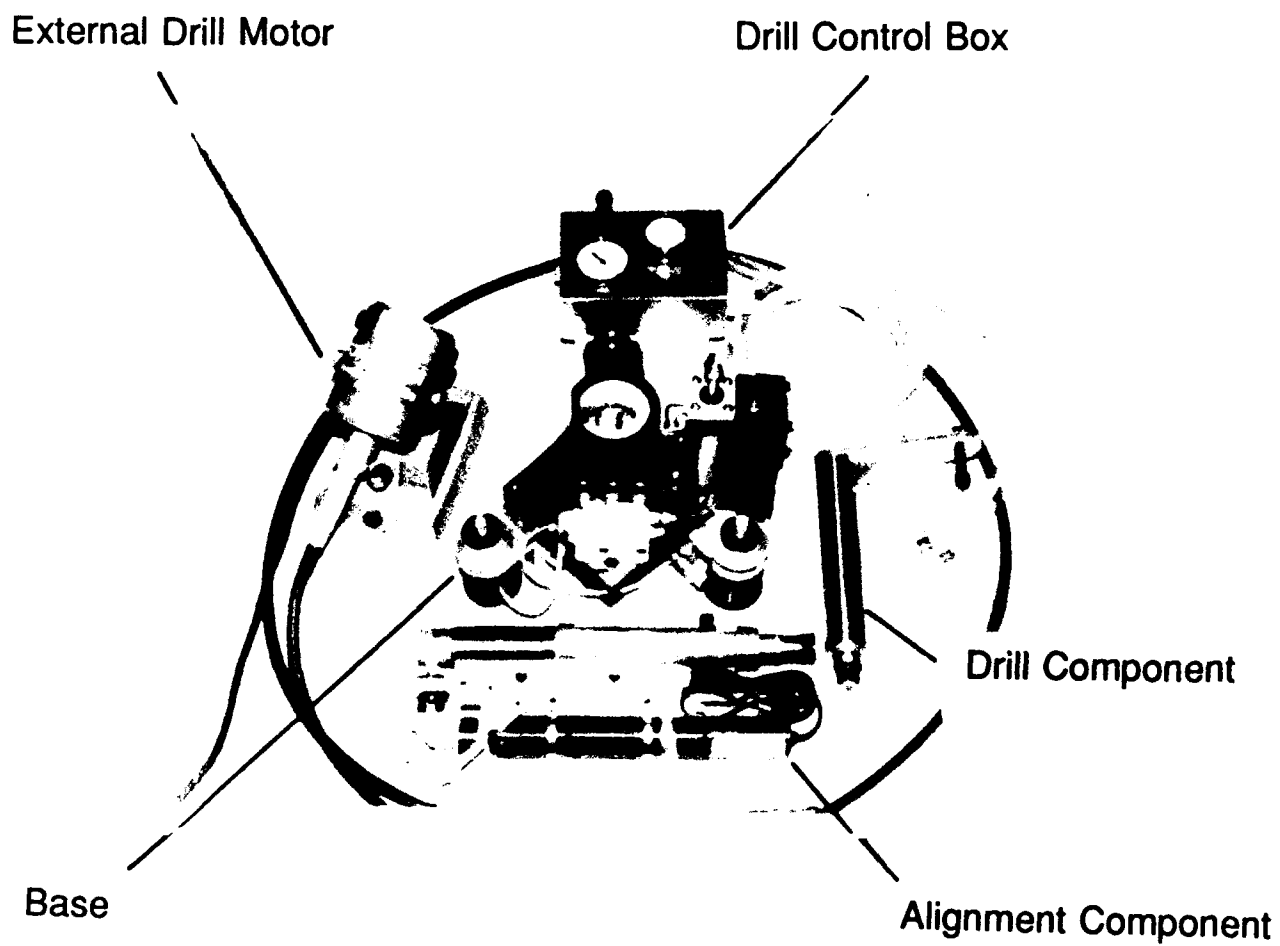
Figure 3.5. Vacuum Attached Laser Aligned Portable Drilling Device.

- **PORTABILITY.** The desire to use the device to quickly collect data from in-service transparencies required the device to be portable. Figure 3.6 highlights vacuum cups at the bottom of the base's swivel feet, which allow quick and convenient attachment. Vacuum lines run from a central manifold positioned on the base. A low consumption venturi type vacuum pump, housed in the control unit, supplies 25-in hg vacuum at 60 psi, thus requiring only a compressed air source to secure the unit. The vacuum is sufficient to firmly attach the unit to the side of the canopy, oriented 90° to the upright position.

- **X-Y AND  $\Theta$  ADJUSTABILITY.** The base of the unit is essentially an optical translation stage with a 2-inch-diameter hole through the center. Micrometers, Figure 3.6, permit smooth and accurate x-y motion used to center the base over the rosette target. Each leg consists of a threaded canister portion, vacuum cups, and locks. Spherical bearings connecting the vacuum fittings to the threaded canister portion allow the feet to rotate as the canister heights are adjusted to bring the base perpendicular to the rosette surface. Locking rings on the canisters and jamming rods on the bearings rigidly fix the orientation of the base.

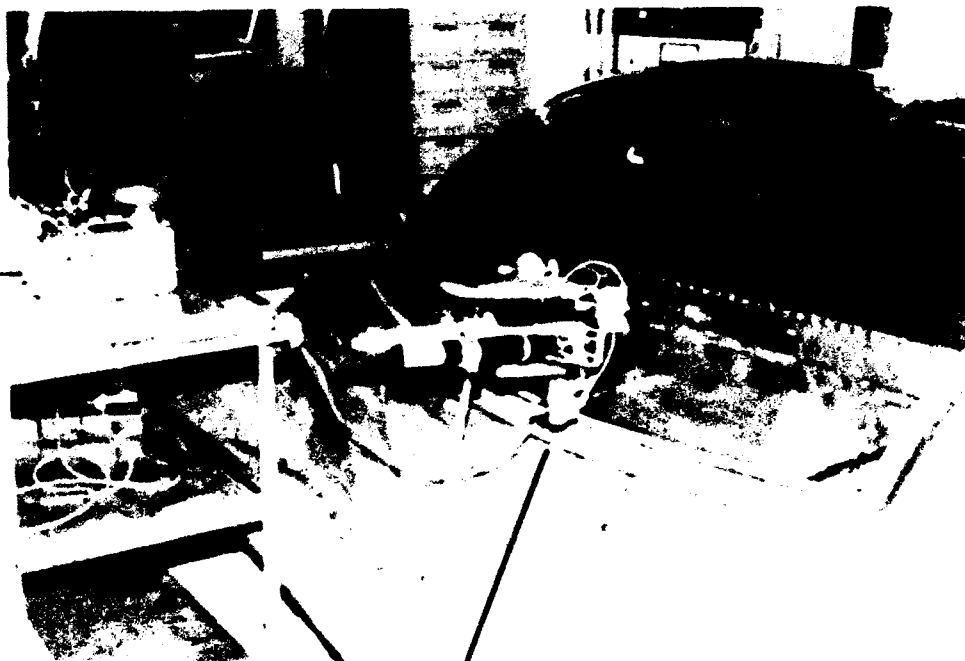
Figure 3.12. Hole Drilling on Installed and Pressurized F-16 Canopy.

The device performed well in measurements in all areas of the canopy, including those in which the device was mounted 90° to the vertical (Figure 3.12). Measurements taken after drilling of free state canopies (Section VI) showed the hole misalignment to average 0.00104 inch, with 47 of the 60 holes misaligned less than 0.0006 inch (the resolution of the micrometer).

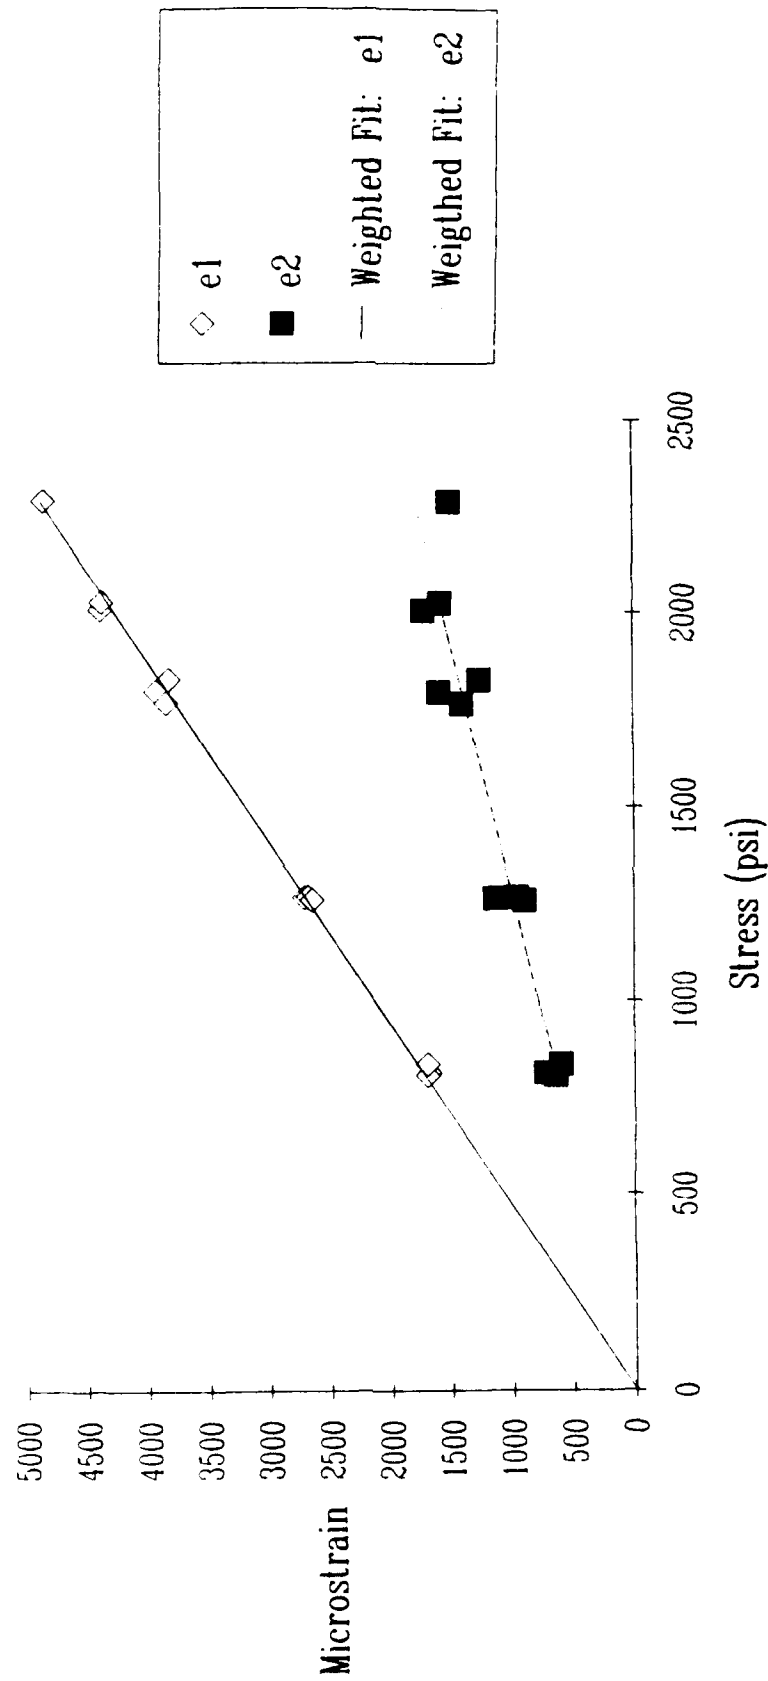
Figure 4.1. Strain Data from Regular Rosette Calibration.

In this study, six rosettes bonded to a single 1/8-inch-thick acrylic specimen and pulled in tension with the same fixture used in calibrating hole drilling specimens furnished the stress/strain data for calculating A and B. The use of seven stress levels and a weighted least squares fit ensured average values for A and B (as in the hole drilling calibration). Figure 4.1 displays the results of the calibration as well as the A and B values obtained.

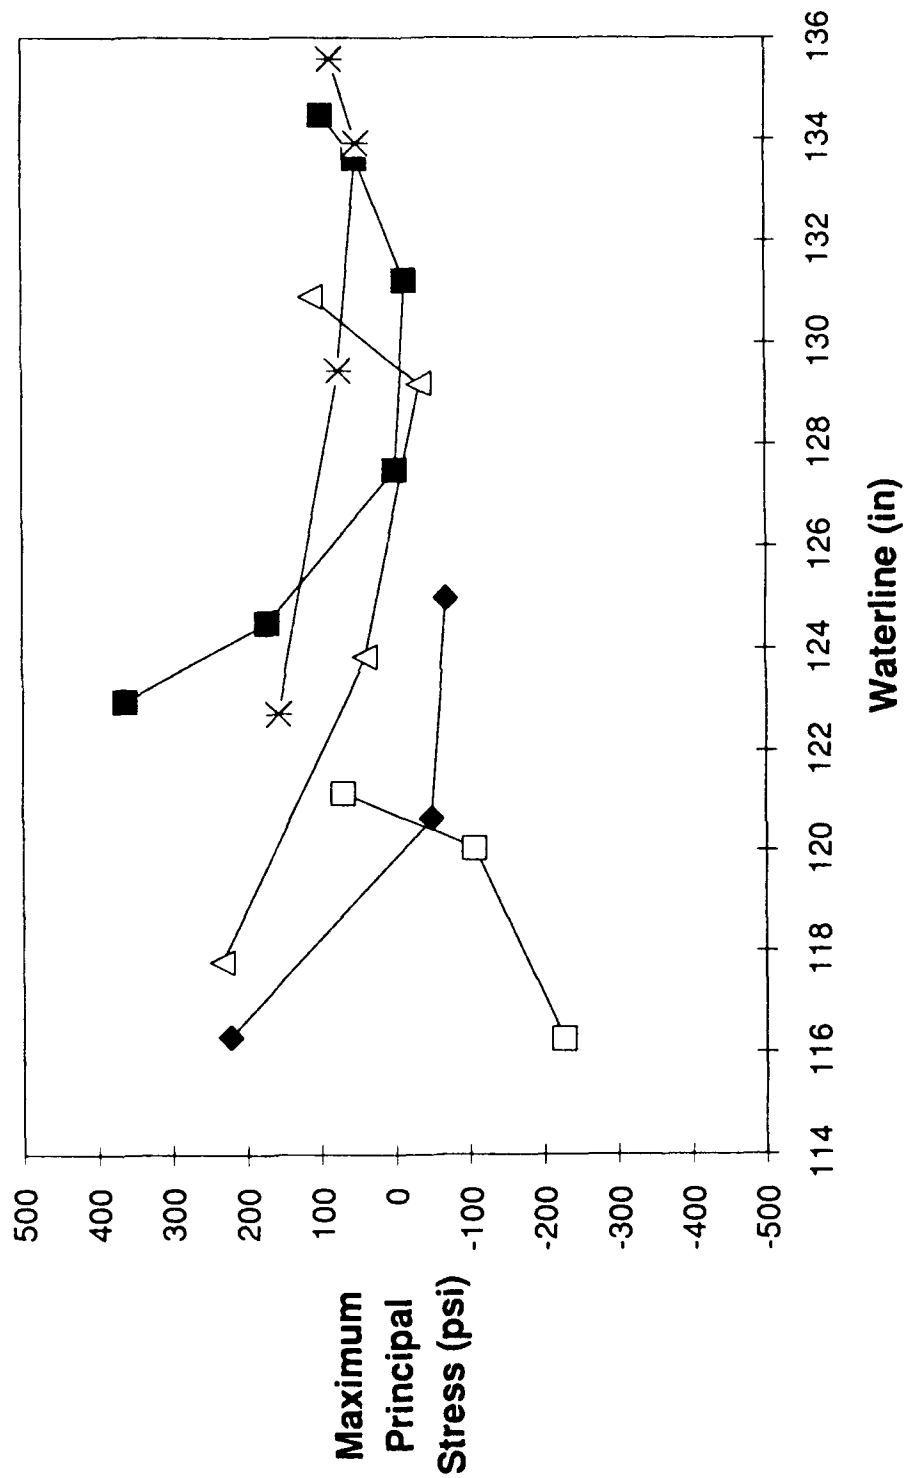
Figure 5.16. Maximum Pressure Stress - Canopy T1.

Pressurizing the mockup fixture with the canopy installed generated strain data comparable to what a typical canopy may see during high altitude flight due to the reduction in external atmospheric pressure. A shop air supply produced sufficient air flow to maintain 6 psig cabin pressure. The poor condition of the fixture required several repair operations, including removal and reinstallation of the aft canopy, sealing of sheet metal seams with 8802 sealing compound, and 1/2-inch-wide strips of butyl rubber placed adjacent to the inflatable seals along the entire perimeter of the cabin. (The butyl rubber required stripping and replacing after each opening of the cabin hatch.) A pressure gage ( $\pm 0.25$  psi accuracy, 15 psi range) mounted through the forward bulkhead fixture indicated cabin pressure.

Upon pressurization to 6 psig, each regular rosette was again connected to the strain indicator, the balance set to the zero point recorded in the free state, and the strain read. The strain noted in this manner represented a superposition of installation and pressure induced deformations. Hole drilling tests were conducted using the VALAPODD at positions specified in Table 5.2.

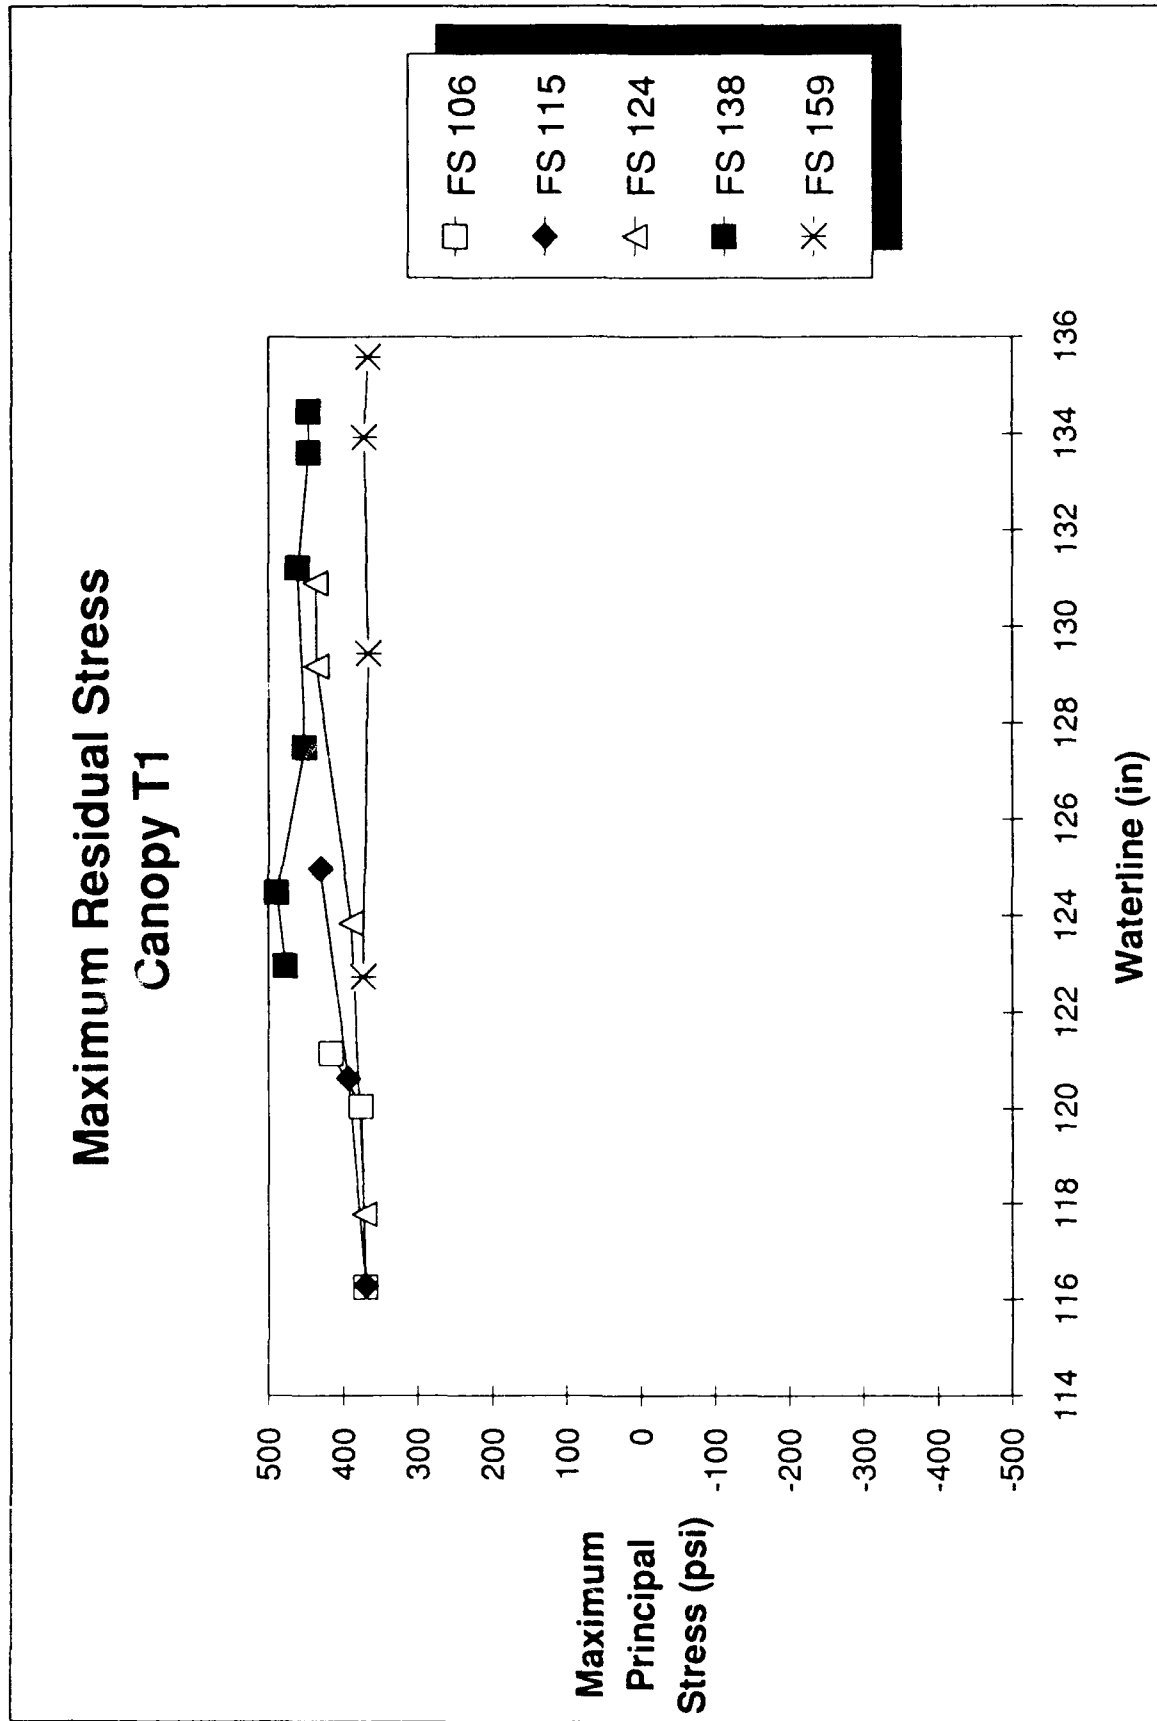
Figure 5.22. Maximum Residual Stress - Canopy T1.

Although these results indicate the Texstar canopy produces the highest residual stresses, the difference in service lives makes the results of such a comparison difficult to interpret. Section 6 will examine residual stresses in more detail through hole drilling tests in 20 in-serviced canopies.

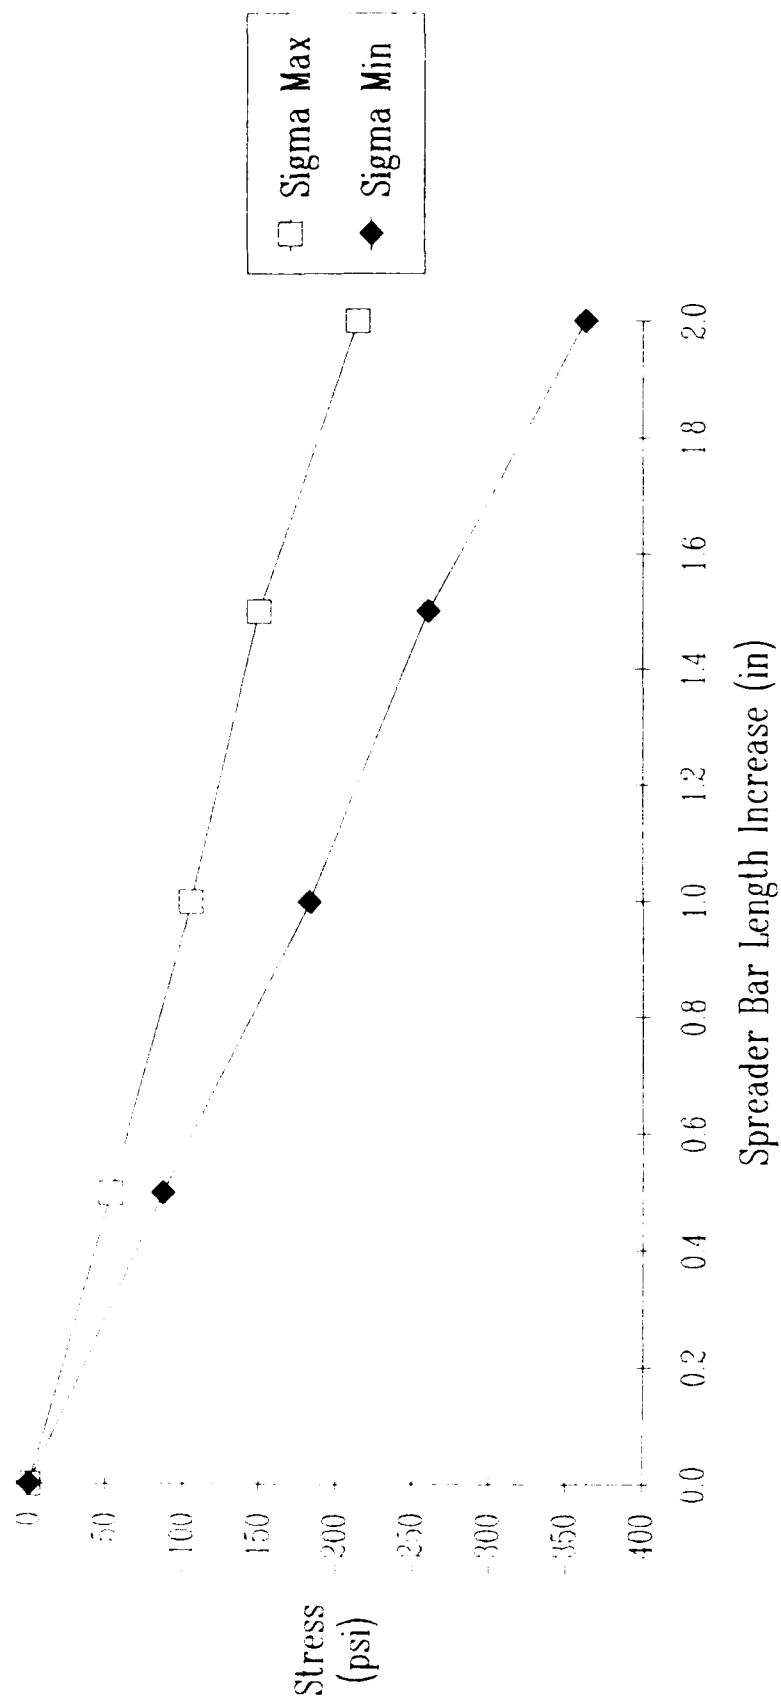
Figure 6.1. Stress Resulting from Deflection by the Spreader Bar.

# Stress Induced by "Free State" Deflection
